# VTS Osteoallograft Orthomix Case 1 Fracture Repair

# VTS Osteoallograft Orthomix Case 2

## Non-Union with Bone Loss

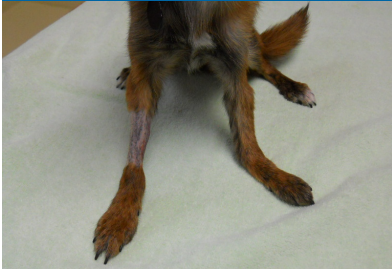
An osteopenic mixed breed dog presented with a radius ulna fracture that occurred subsequent to two previous fractures in the same leg. Both previous repairs were done without bone graft. →

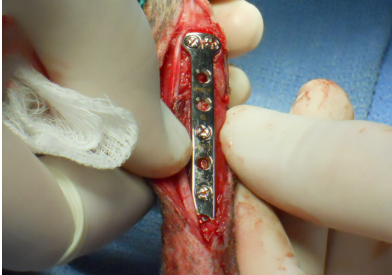
A 1.5 mm Synthes T plate is used to stabilize the fracture. →

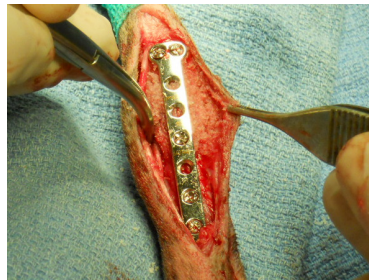
After placement of the bone allograft, the surgery site is ready for closure.

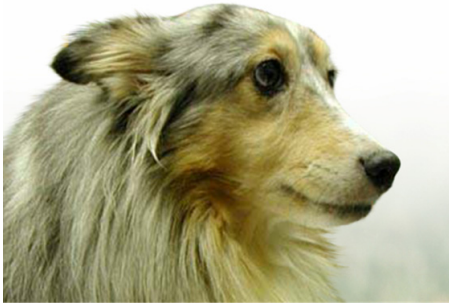
7 year-old Sheltie named Delenn presented with a re-fracture through a previous femoral non-union with significant bone loss.

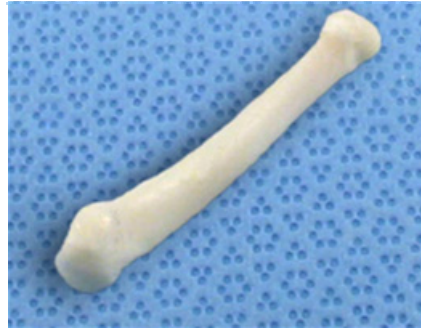
A metacarpal segment was used to replace the resorptive section and in addition, the particulate **Osteoallograft® Orthomix®**, was used to provide enhanced access to growth factors.

The metacarpal segment is placed and secured with the plate. **Osteoallograft® Orthomix® Fine** was packed around the graft/host junctions.

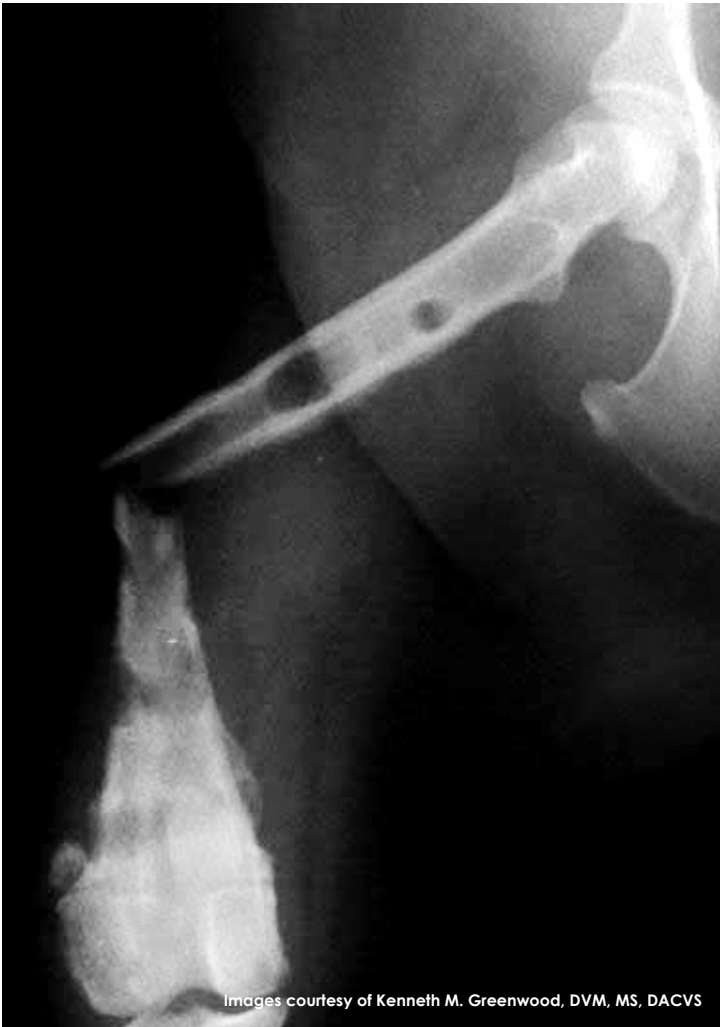
### PRE OP:

The pre op radiograph shows the extent of bone loss that occurred with this femoral non-union.

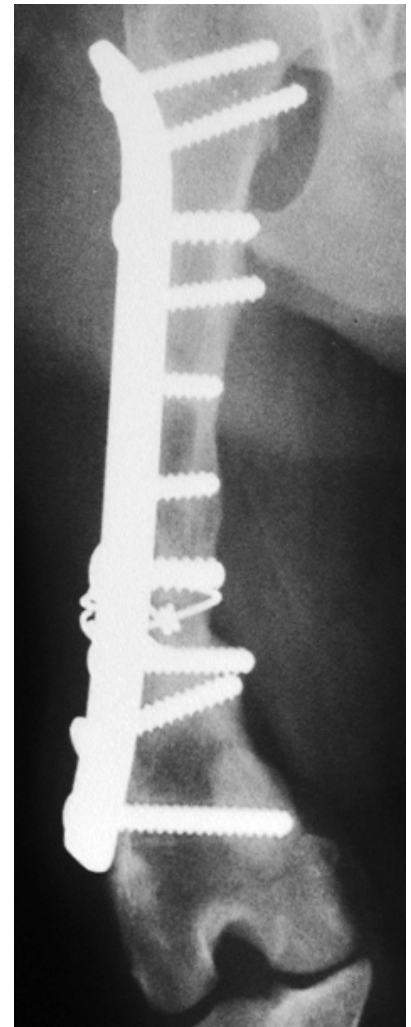
### 7 MONTH FOLLOW UP:

The fracture is fully healed. The allograft segment has become integrated and a continuous cortex is clearly visible.
