Periodontal Disease - A Case Study

Use of an alloplast material to treat a 309 furcation defect

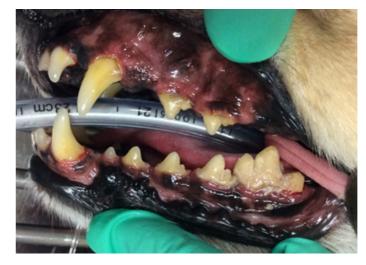
Figure 1. Photograph of the left side of Wombat's mouth demonstrating increased plaque and calculus accumulation.

Note: due to loss of the caudal maxillary teeth, 309 has plaque build-up and gingival inflammation

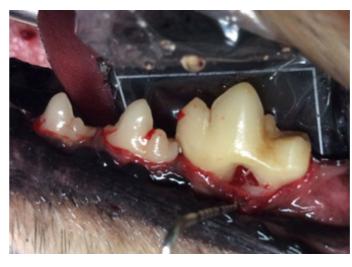
Figure 2. Photograph 309 after envelope flap and root planning was completed. Note: furcation exposure and radiograph sensor placed lingually

A left inferior alveolar nerve block was placed. Complete supra- and sub-gingival scaling was performed using an ultrasonic scaler followed by polishing with a fluoride free pumice. The pumice was removed with a fine jet of water. An envelope flap of the buccal gingiva adjacent to 309 was raised using a Molt 2/4 periosteal elevator and open root planing using a miniature Gracey 1/2 curette debrided the root surfaces of endotoxins, diseased cementum/ dentin, plaque and calculus. The exposed roots were polished with a fluoride free pumice and washed with a fine jet of water. Once visually clean, an alloplast comprising hydoxyapatite and beta tricalcium phosphate (Synergy) was placed into the furcation defect (Figure 4). The flap was replaced and finger pressure applied for 2 minutes. A thin layer of Super Glue was used to attach the flap margin to the enamel, followed by drying and applying SANOS resin (Figure 5).

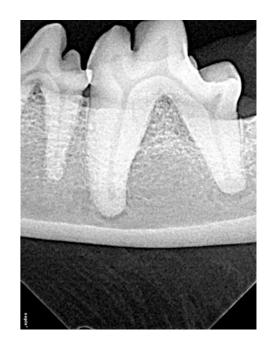
A post-op radiograph showed the furcation successfully filled with the alloplast (Figure 6). Wombat recovered from anaesthesia uneventfully. She was discharged the same day with metronidazole 100mg PO bid, Amoxycillin/clavulanic acid 91.75mg PO bid, and instructions to apply a pea-size drop of Maxiguard Oral gel to the flap bid and to feed soft food for 14 days. An appointment was scheduled for the same time.

Figure 6. Radiograph 309 after placement of Synergy
