# VTS Osteoallograft Orthomix Case 1 Fracture Repair

Xena  
5.6 pounds  
Chihuahua mix

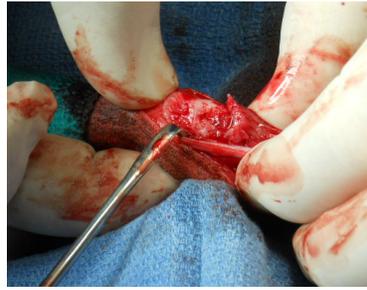
The fracture is exposed, debrided and prepared for plate placement.

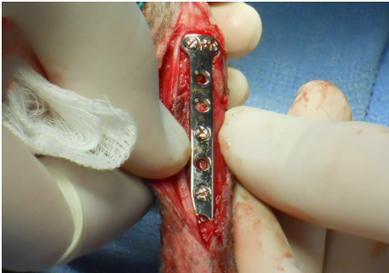
A 1.5 mm Synthes T plate is used to stabilize the fracture.

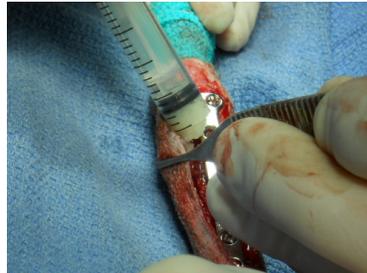
**Osteoallograft® Orthomix® Ultra Fine** is placed on the lateral and medial sides of the fracture.

The graft may also be mixed with patient blood prior to application.

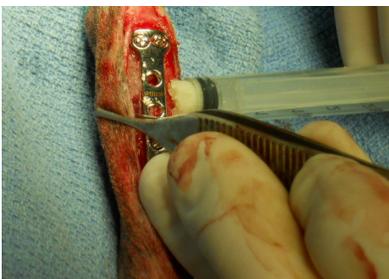
Allograft particles increase surface area and provide increased amounts of native growth factors that attract osteoprogenitor cells to facilitate healing.

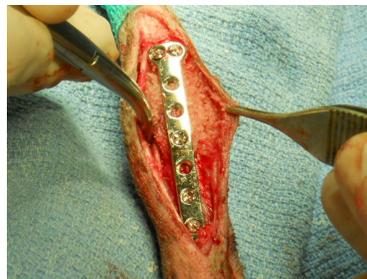
After placement of the bone allograft, the surgery site is ready for closure.
