VTS Osteoallograft Periomix Case 7

Dental Implant

VTS Cancellous Bone Block Case

Large Extraction Site

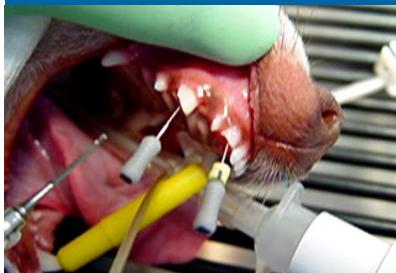
2.5 year-old Chihuahua mix presented with face trauma creating a canine and incisor fracture with pulp exposure. Also note a deformed lateral incisor.

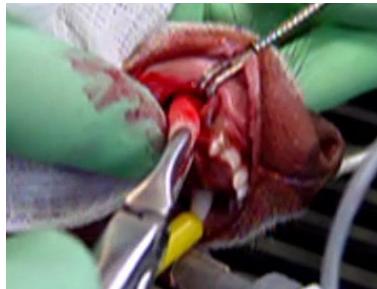
All involved teeth were atraumatically extracted to preserve as much alveolar bone as possible.

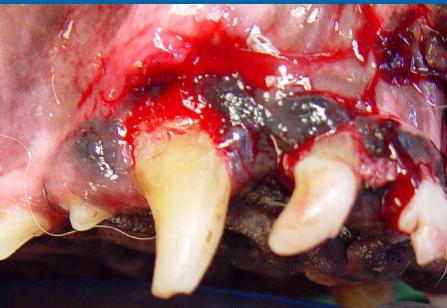
11 year-old Australian Shepherd named Rosie presented with a fractured canine, gingival edema and deep palatal infrabony pockets.

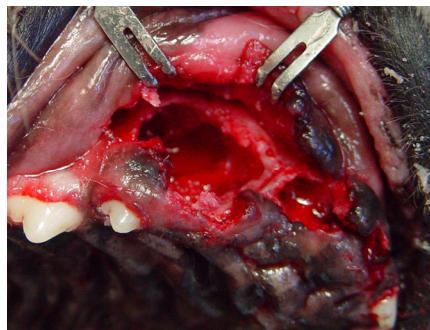
Only after affected teeth were extracted and the inflammatory tissue was removed from the socket, could the extensive damage to the alveolar bone be seen.

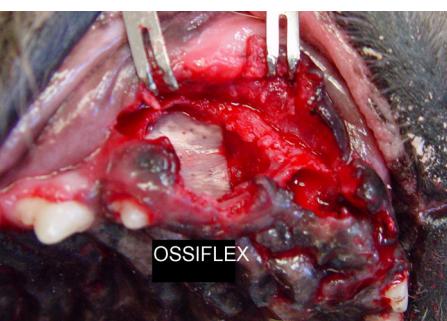
The alveolar-nasal defect was repaired with a flexible laminar bone graft (**Ossiflex™ Bone Membrane**).

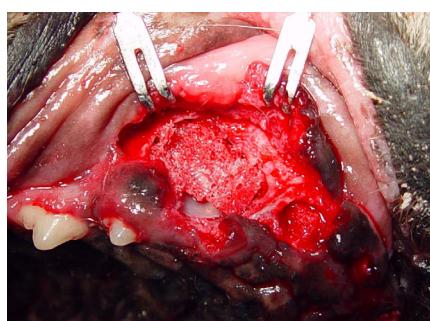
The large extraction site is then filled with a cancellous bone block allograft from VTS.

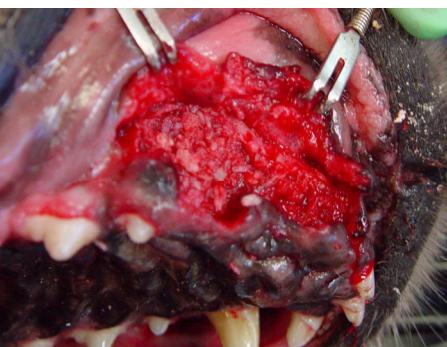
Osteoallograft® Periomix® is placed around the coronal and apical area of the cancellous block for a complete fill of the extraction site.

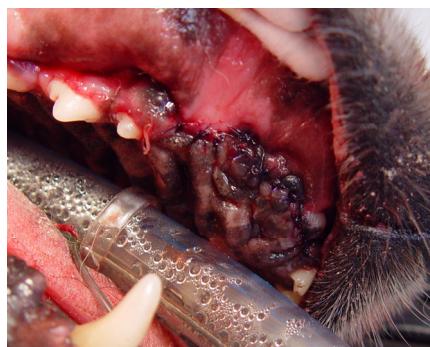
The gingival flap is sutured closed.

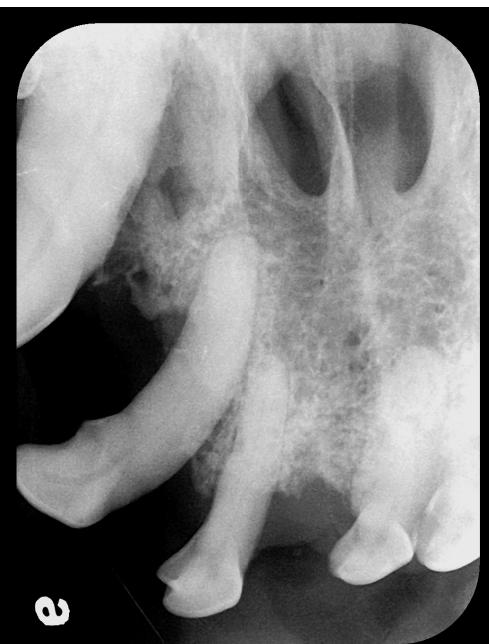
PRE OP:

The pre-op radiograph shows bone loss resulting from necrosis of the supporting bone. Note the nasal fistula tract.

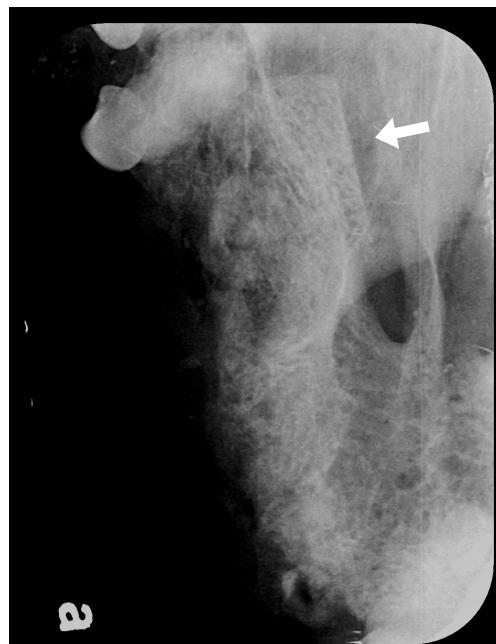
POST OP:

The post-op radiograph shows the margins of the cancellous bone block allograft in the extraction site surrounded by **Osteoallograft® Periomix®**.

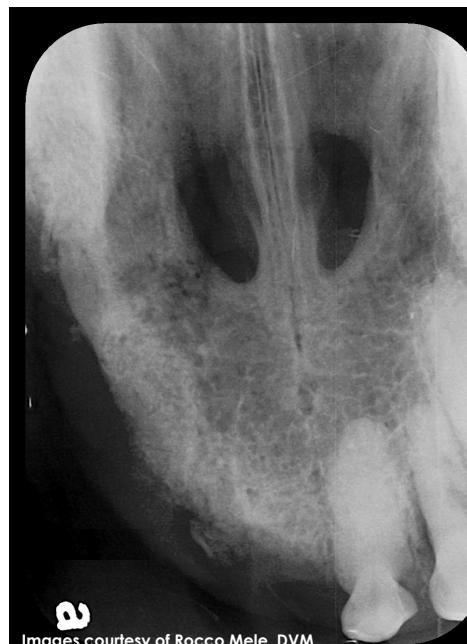
4 WEEK FOLLOW UP:

At only 4 weeks post surgery, the cancellous block appears fully integrated into the host bone and bone density has significantly improved.
