VTS Osteoallograft Orthomix Case 1 Fracture Repair

vs Osteoallograft Orthomix Case 2

Non-Union with Bone Loss

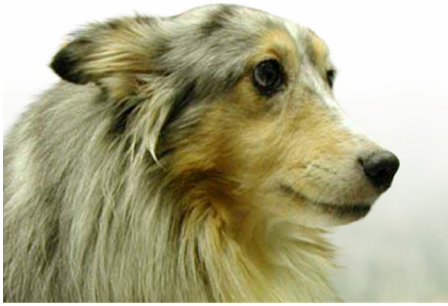
7 year-old Sheltie named Delenn presented with a re-fracture through a previous femoral non-union with significant bone loss.

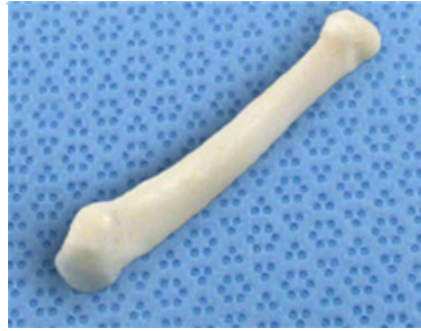
A metacarpal segment was used to replace the resorptive section and in addition, the particulate **Osteoallograft® Orthomix®**, was used to provide enhanced access to growth factors.

The metacarpal segment is placed and secured with the plate. **Osteoallograft® Orthomix® Fine** was packed around the graft/host junctions.

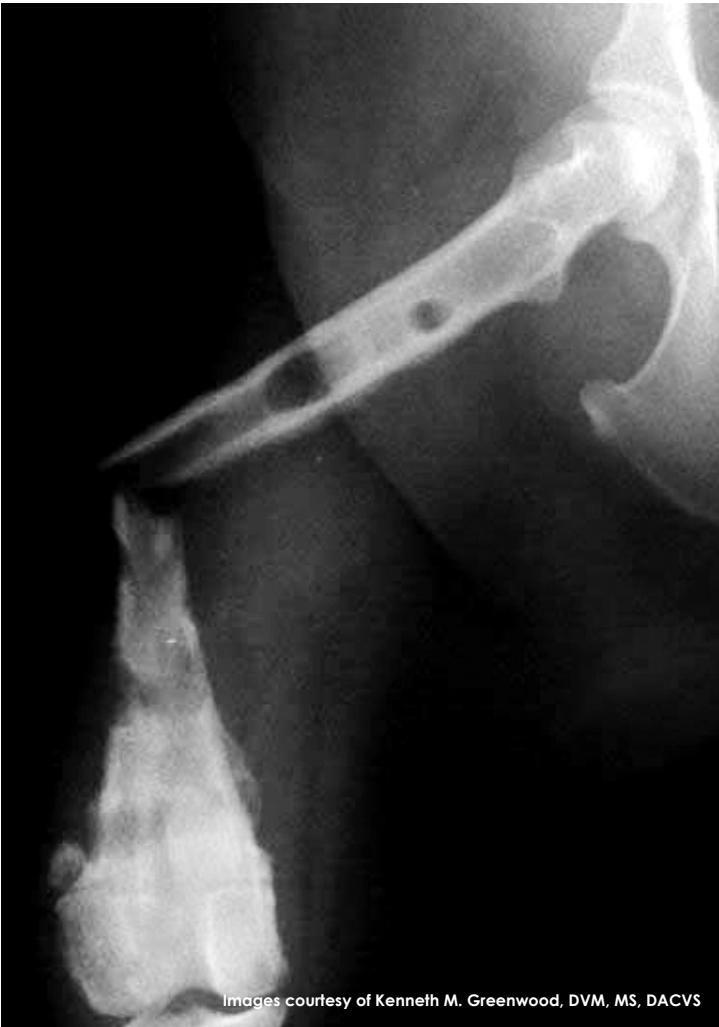
PRE OP:

The pre op radiograph shows the extent of bone loss that occurred with this femoral non-union.
