VTS Osteoallograft Orthomix Case 1 Fracture Repair

Xena
5.6 pounds
Chihuahua mix

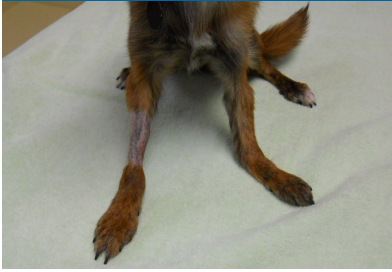
An osteopenic mixed breed dog presented with a radius ulna fracture that occurred subsequent to two previous fractures in the same leg. Both previous repairs were done without bone graft. →

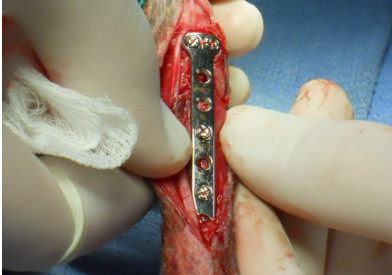
A 1.5 mm Synthes T plate is used to stabilize the fracture. →

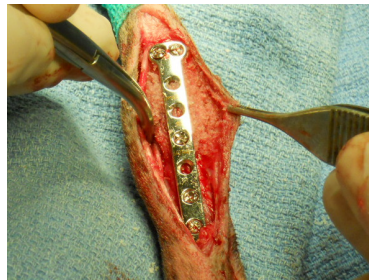
After placement of the bone allograft, the surgery site is ready for closure.
