vis Osteoallograft Periomix Case 7 Dental Implant

VTS Cancellous Bone Block Case

Large Extraction Site

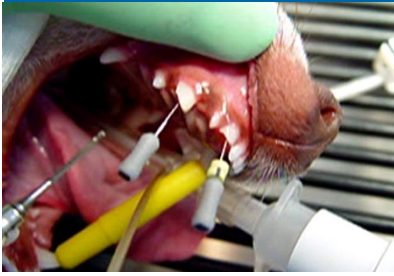
2.5 year-old Chihuahua mix presented with face trauma creating a canine and incisor fracture with pulp exposure. Also note a deformed lateral incisor.

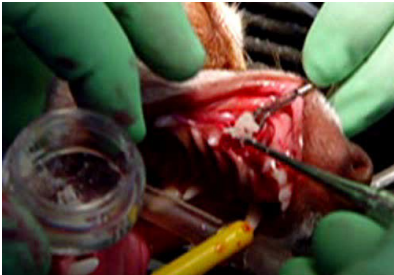
The extraction site is filled with **Osteoallograft® Periomix®**.

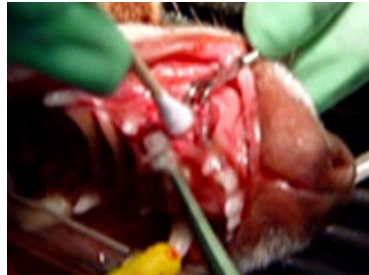
The bone allograft is compacted into the apical area of the alveolus to ensure complete and dense filling.

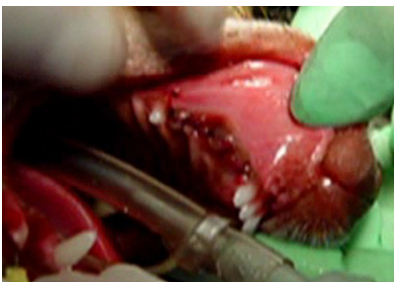
After all affected teeth were surgically extracted and grafted, the gingival flap has been sutured closed.

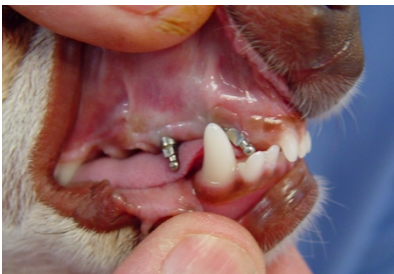
24 weeks after the extractions, the implants are immobile and ready for the impressions.

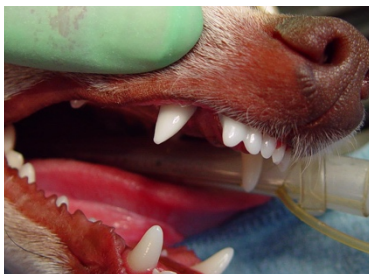
The canine pontic and a 2-unit bridge are cemented onto the abutments. They are beautiful and – most importantly – rock solid.

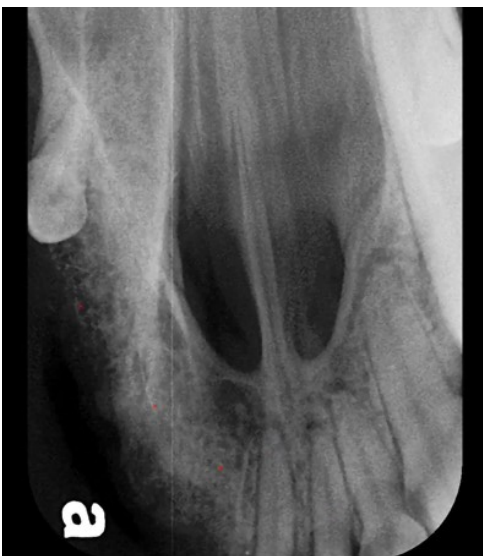
POST OP:
Extraction sites are filled with **Osteoallograft® Periomix®**.

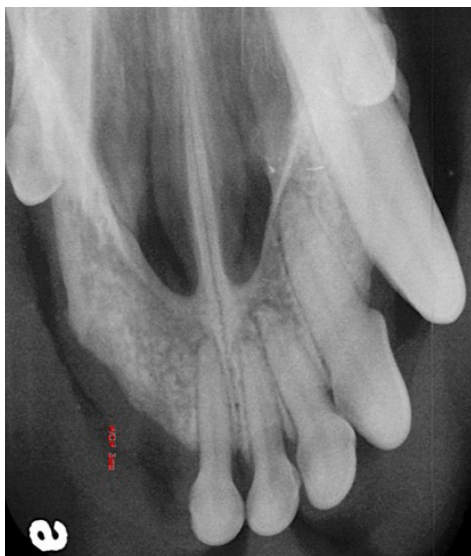
12 WEEK FOLLOW UP:
At 12 weeks, the radiograph shows dense bone. Says Dr. Mele, “We are into very, very good bone [suitable for implants].”

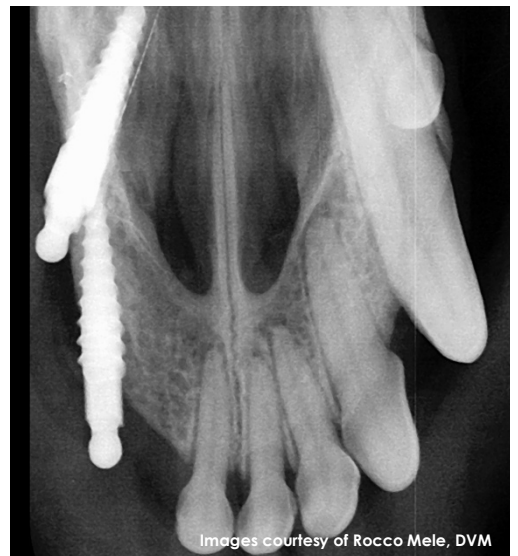
24 WEEK FOLLOW UP:
At the 24 week follow-up, the implants are anchored into the maxilla and ready for bridge placement.

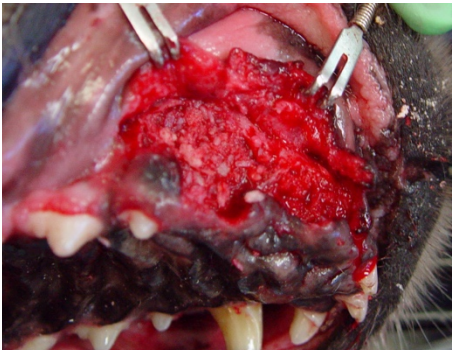
Osteoallograft® Periomix® is placed around the coronal and apical area of the cancellous block for a complete fill of the extraction site.

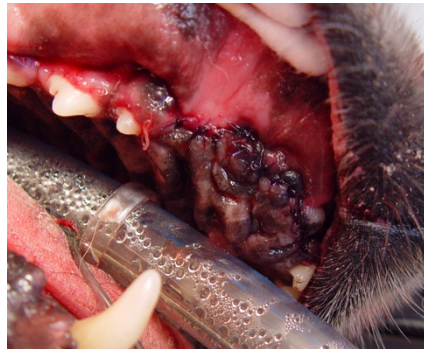
The gingival flap is sutured closed.

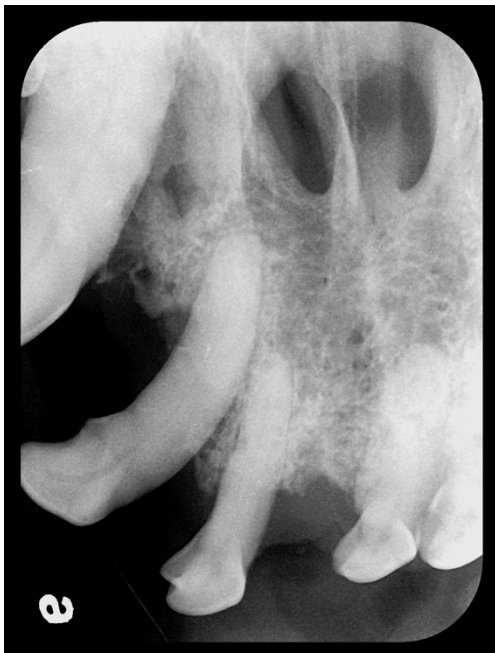
PRE OP:

The pre-op radiograph shows bone loss resulting from necrosis of the supporting bone. Note the nasal fistula tract.

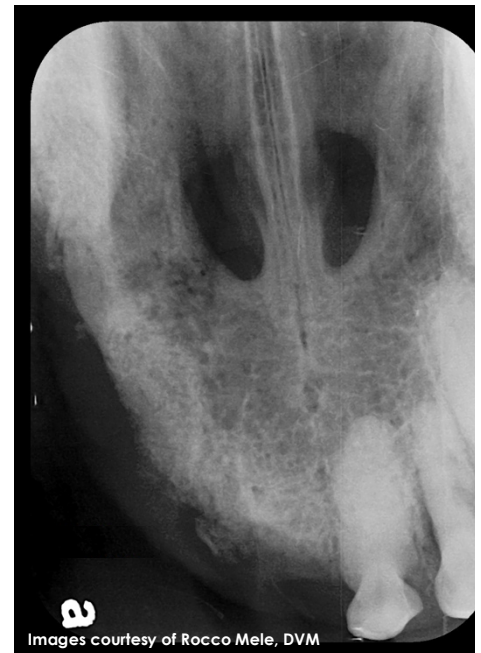
4 WEEK FOLLOW UP:

At only 4 weeks post surgery, the cancellous block appears fully integrated into the host bone and bone density has significantly improved.
