vis Osteoallograft Periomix Case 7 Dental Implant

Sam
2.5 years old
Chihuahua mix

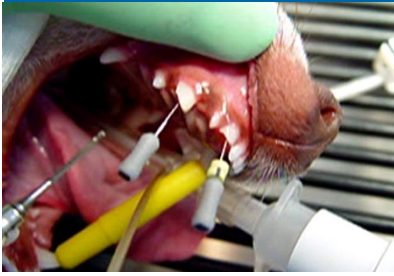
2.5 year-old Chihuahua mix presented with face trauma creating a canine and incisor fracture with pulp exposure. Also note a deformed lateral incisor.

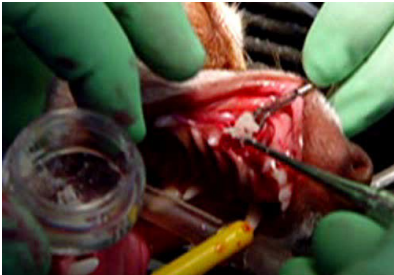
The extraction site is filled with **Osteoallograft® Periomix®**.

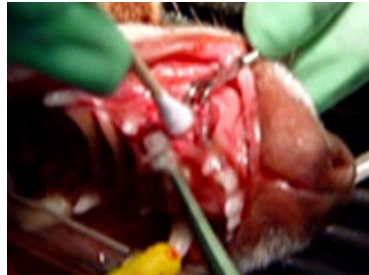
The bone allograft is compacted into the apical area of the alveolus to ensure complete and dense filling.

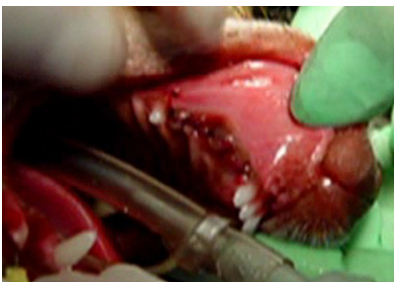
After all affected teeth were surgically extracted and grafted, the gingival flap has been sutured closed.

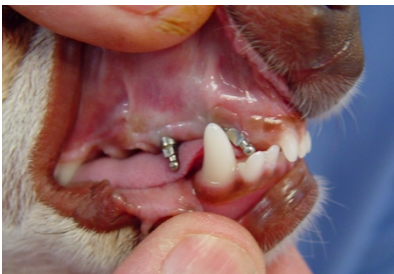
24 weeks after the extractions, the implants are immobile and ready for the impressions.

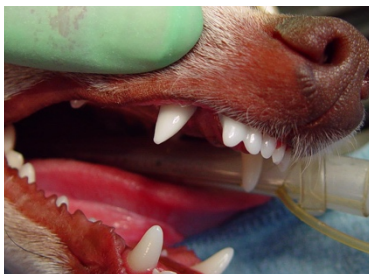
The canine pontic and a 2-unit bridge are cemented onto the abutments. They are beautiful and – most importantly – rock solid.

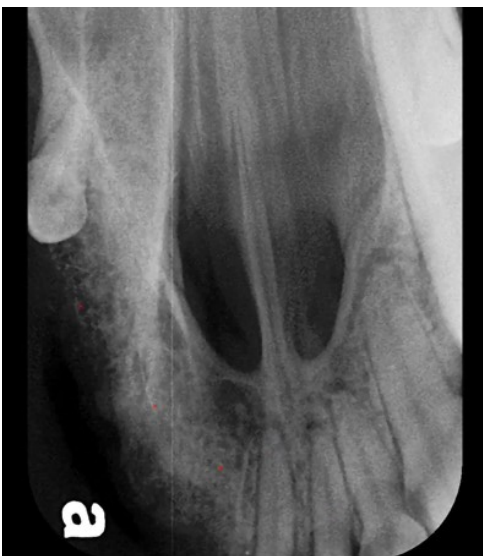
POST OP:
Extraction sites are filled with **Osteoallograft® Periomix®**.

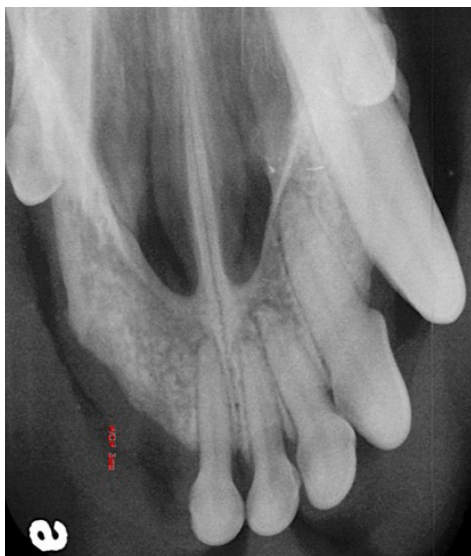
12 WEEK FOLLOW UP:
At 12 weeks, the radiograph shows dense bone. Says Dr. Mele, “We are into very, very good bone [suitable for implants].”

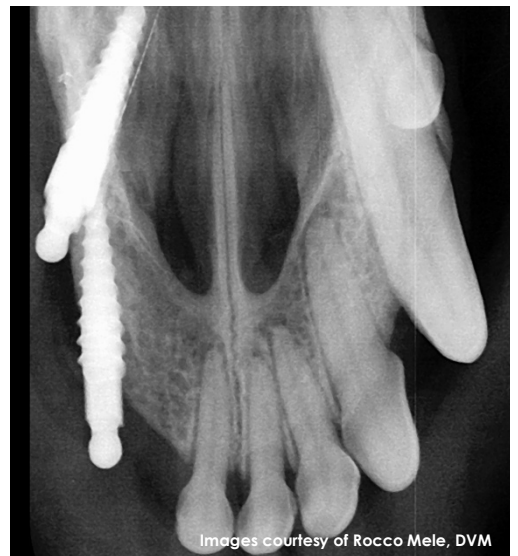
24 WEEK FOLLOW UP:
At the 24 week follow-up, the implants are anchored into the maxilla and ready for bridge placement.
