## vs Osteoallograft Periomix Case 1 Preserving Teeth

## vs Osteoallograft Periomix Case 2 Bilateral Mandibular Fracture Repair

## VTs Osteoallograft Periomix Case 3

## VTs Osteoallograft Periomix Case 4

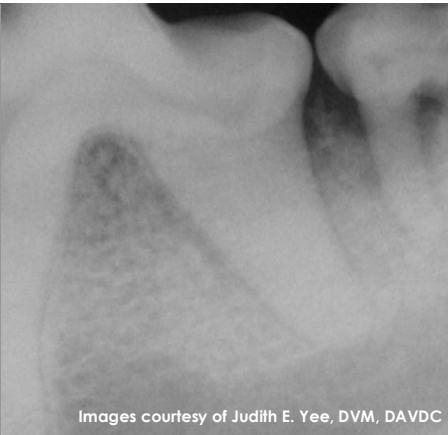
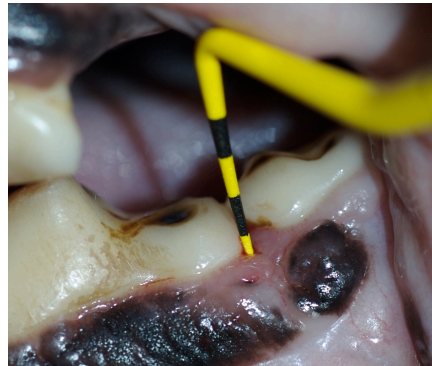
The gingival defect has completely healed with no recession at the site. "This outcome was quite remarkable," said Dr. Yee, "Ordinarily at least part of that tooth would have required extraction."

Follow-up at 8 weeks: Reconstruction of periodontium to a 2 mm probing depth has occurred and extraction has been avoided.

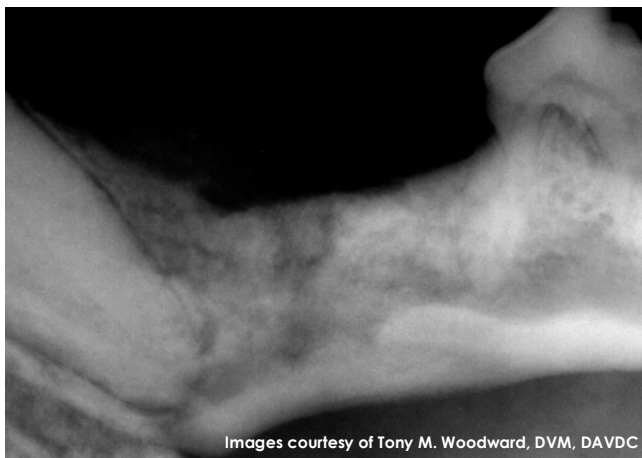
Both fracture sites were well-healed and had filled in with normal bone. No mobility was present. Said Dr. Woodward, "To say I am amazed would be putting it lightly."

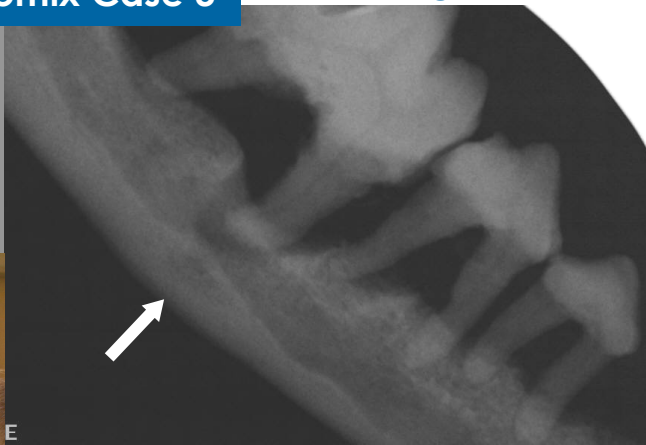
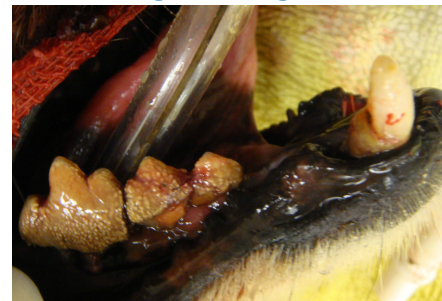
Severe periodontal disease resulted in >50% horizontal and vertical bone loss. There was significant potential for a mandibular fracture.

Right mandible before surgery. There was marked calculus and periodontal disease.

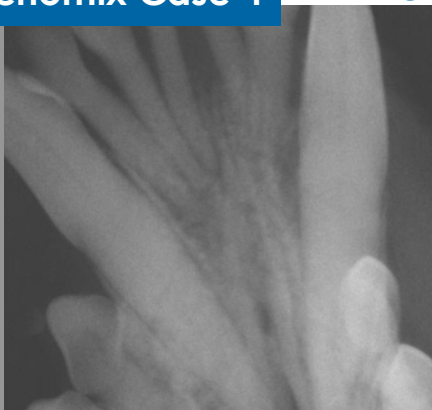
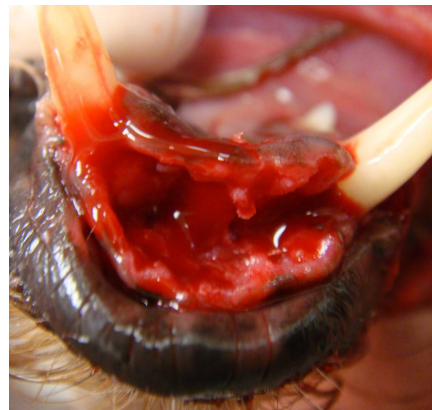
One mandibular incisor was missing and the rest were mobile. The canines had 6 mm mesial pockets and there was >50% bone loss. The extreme loss of bone increased the risk of loss of both canine teeth.

All incisors had to be extracted, leaving deep extraction sites. Bone stock was compromised, raising concern that the canines would exfoliate.
